# ENGINEERED COMPOSITE SOLUTION

**FUTUREWRAP**

## **ASSURED INTEGRITY GROUP INCORPORATED**

### Case study – 4 inch seawater injection flowline suffering internal corrosion

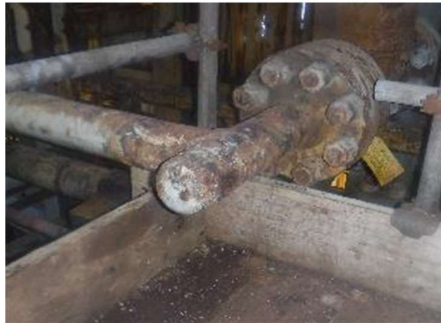
A 4 inch seawater flowline was suffering from internal corrosion. The measured wall thickness of 12.8 mm was below the CONC value. It was proposed to use a Futurewrap composite repair to reinstate the integrity of the pipework.

Initial condition of pipework

The design of the Futurewrap repair was according to ISO 24817. The design approach was for pipework strengthening only with allowance for the remaining wall thickness of the pipework. The design parameters were; internal pressure 355 bar, temperature 40°C, design lifetime 2 years, remaining wall thickness of steel 12 mm. The repair design resulted in a thickness of 11.35 mm (15 layers) of Futurewrap Glass/LT with an axial length of repair of 440 mm.

The installation steps are shown in the photographs. The pipework was depressurised. The surface preparation was to ST3. Full QA/QC measurements were made to demonstrate that the Futurewrap repair was applied in accordance with ISO 24817.

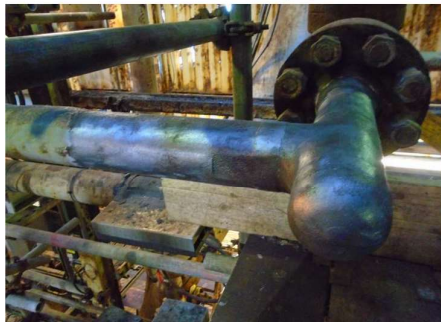
After surface preparation

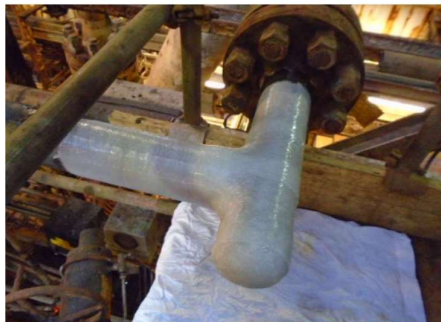
During repair application

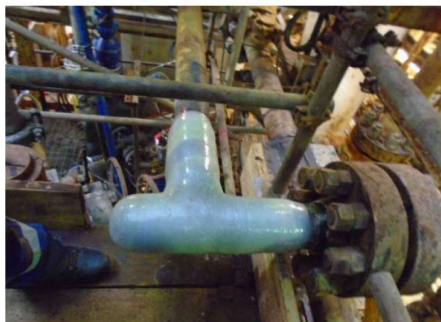
Completed repair

A 4 inch seawater flowline suffering internal corrosion was repaired using a Futurewrap Glass/LT composite repair. The repair was completed within 3 days allowing the pipework to be re-pressurised with the pipework returned to its original integrity.

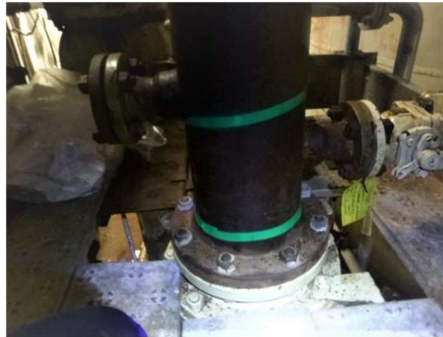
A 8 inch produced water pipework was suffering from internal corrosion. Localised internal corrosion had caused severe pitting which was expected to do through wall within months. It was proposed to use a Futurewrap composite repair to reinstate the integrity of the pipework.

Initial condition of pipework

The design of the Futurewrap repair was according to ISO 24817. The design approach was for pipework strengthening and leak sealing. The design parameters were; internal pressure 19.6 bar, temperature 40°C, design lifetime 2 years, through wall defect size 25 mm diameter. The repair design resulted in a thickness of 5.1 mm (8 layers) of Futurewrap Glass/LT composite repair with an axial length of 750 mm.

The installation steps are shown in the photographs. The pipework was depressurised. The surface preparation was to ST2. Full QA/QC measurements were made to demonstrate that the Futurewrap repair was applied in accordance with ISO 24817.

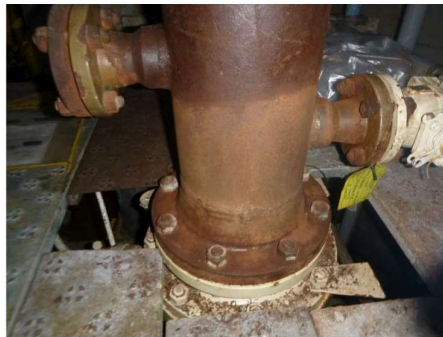
After surface preparation

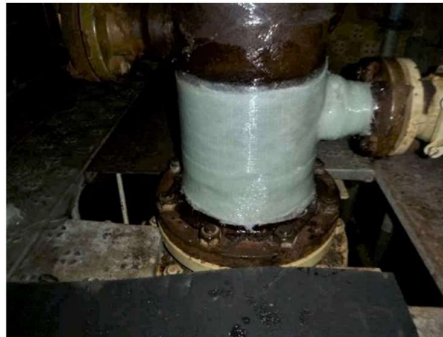
During repair application

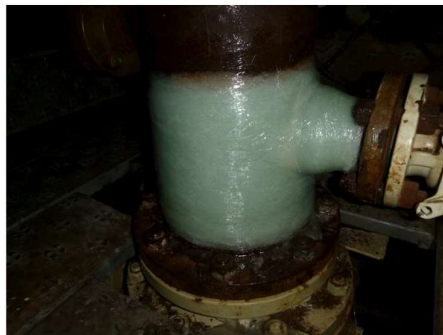
Completed repair

A 8 inch produced water pipework suffering internal corrosion was repaired using Futurewrap Glass/LT composite repair. The repair was completed within 2 days allowing the pipework to be re-pressurised returning the pipework to its original integrity.

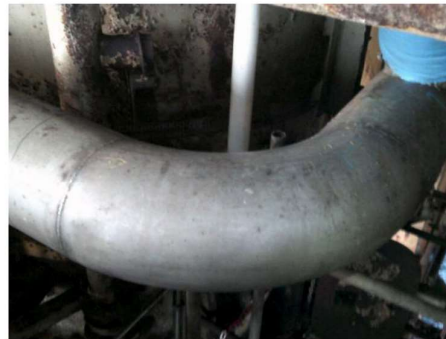
A 10 inch mixed HP flare line was suffering from external corrosion. The external corrosion was so severe in places that the design premise was to assume a through wall defect. It was proposed to use a Futurewrap composite repair to reinstate the integrity of the pipework.

Initial condition of pipework

The design of the Futurewrap repair was according to ISO 24817. The design approach was for pipework strengthening and leak sealing. The design parameters were; internal pressure 8.1 bar, temperature 90°C, design lifetime 10 years, through wall defect. The repair design resulted in a thickness of 5 mm (6 layers) of Futurewrap Glass/LT composite repair with an axial length of 1350 mm.

The installation steps are shown in the photographs. The pipework was depressurised. The surface preparation was to ST3. Full QA/QC measurements were made to demonstrate that the Futurewrap repair was applied in accordance with ISO 24817.

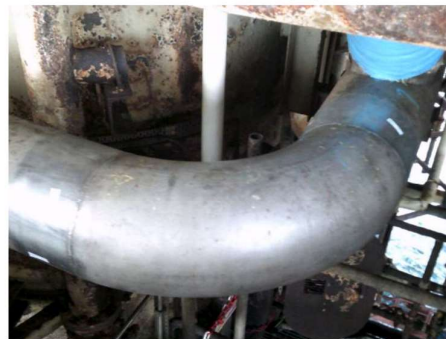
After surface preparation

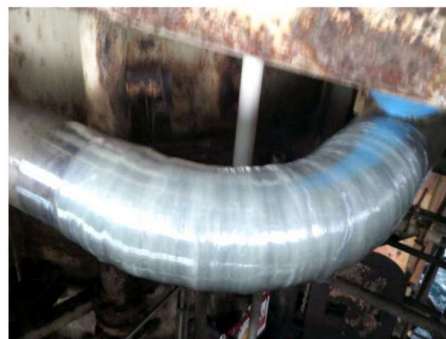
During repair application

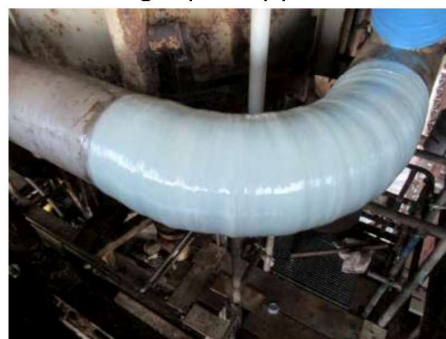
Completed repair

A 12 inch HP flare line suffering external corrosion was repaired using Futurewrap Glass/LT composite repair. The repair was completed within 4 days allowing the pipework to be re-pressurised returning the pipework to its original integrity.

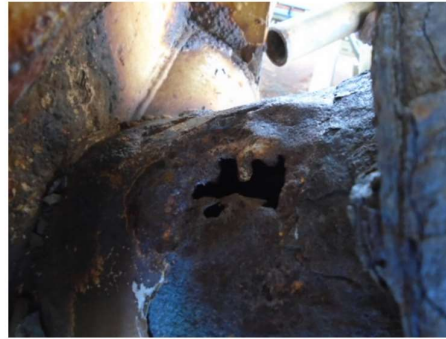
A 8 inch stub (carbon steel) was suffering from external corrosion. The external corrosion was sufficiently severe that the remaining wall thickness would not provide sufficient strength to withstand the acting structural loads. It was proposed to use a Futurewrap Structural composite repair to reinstate the strength of the 8 inch stub.

Initial condition of stub

The design of the Futurewrap Structural repair was to replace the strength reduction due to loss of wall thickness. The design parameters were; thickness of steel to be replaced 7 mm, temperature 30°C, design lifetime 10 years. The repair design resulted in a thickness of 12 mm (10 layers) of Futurewrap Structural Carbon/LT composite repair with an axial length of 290 mm.

The installation steps are shown in the photographs. The surface preparation was to Sa2.5. Full QA/QC measurements were made to demonstrate that the Futurewrap repair was applied in accordance with ISO 24817.

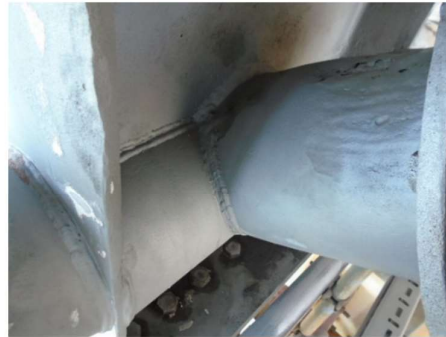
After surface preparation

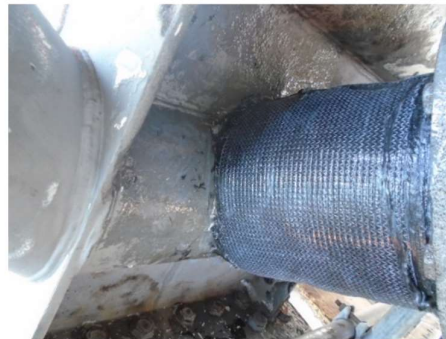
During repair application

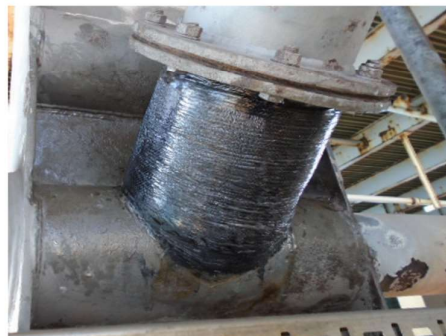
Completed repair

A 8 inch stub suffering external corrosion was repaired using Futurewrap Structural Carbon/LT composite repair. The repair was completed within 3 days returning the strength of the stub to its original value.

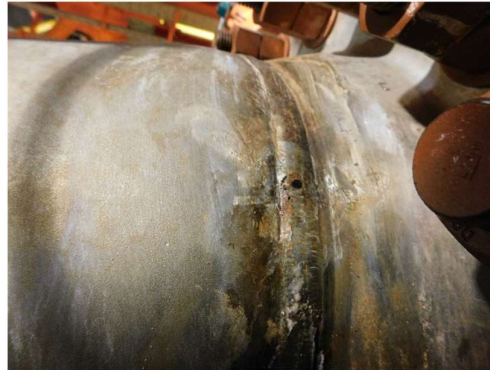
The welds on two sections of pipework on a 10 inch water injection system constructed from super duplex steel were suffering from internal corrosion coupled with manufacturing defects. The weld defects were through wall. To reinstate the integrity of these sections of pipework it was proposed to use a Futurewrap Glass/HT composite repair.

Initial condition of weld

The design of the Futurewrap Glass/HT repair was to both seal the through wall defect and strengthen the pipework assuming the internal corrosion had completely removed the weld. The design parameters were; pressure 18.5 bar, temperature 70°C, design lifetime 20 years. An HT repair was used as the pipework surface temperature during application would be 70°C implying that rapid curing of the repair during installation would be an issue. The repair design resulted in a thickness of 6.5 mm (8 layers) of Futurewrap Glass/HT composite repair with an axial length of 650 mm.

The installation steps are shown in the photographs. The surface preparation was to ST3. Rapid resin curing was controlled. Full QA/QC measurements were made to demonstrate that the Futurewrap repair was applied in accordance with ISO 24817.

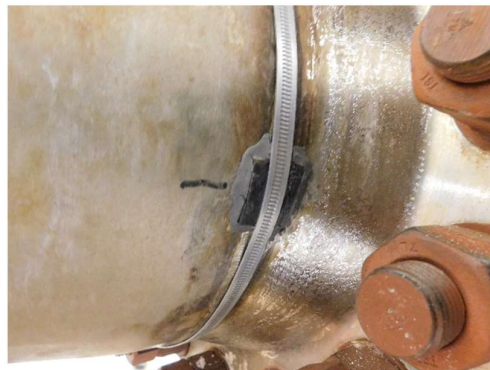
After surface preparation and profiling

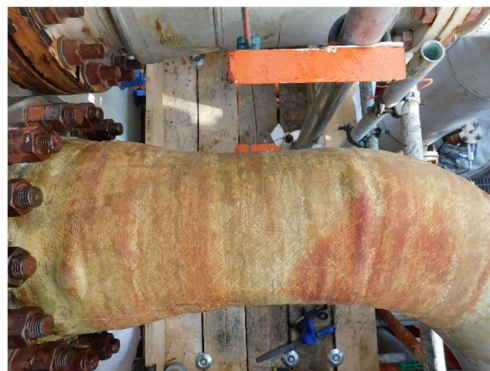
Completed repair

Welds on two 10 inch sea water injection super duplex pipework suffering internal corrosion coupled with manufacturing defects were repaired using Futurewrap Glass/HT composite repair. The repair was completed within 3 days reinstating the integrity of the pipework.

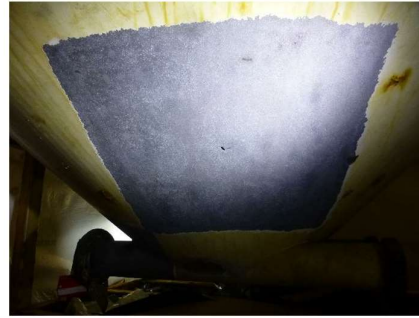
A CSU drilling mud tank, 2.8 meter diameter, which had been out of service for several years was to be re-commissioned. There were several holes in the main body of the tank as well as in the pipework attachments. The cause of these through wall defects was internal erosion/corrosion. A repair solution was sought to return the tank to service using an engineered Futurewrap repair. To reinstate the integrity of the tank, it was proposed to use several Futurewrap Glass/LT composite repairs on the tank main body and associated pipework.

Initial status of tank body – Patch 1

The design of the Futurewrap Glass/LT repair was to seal and strengthen the tank. The design parameters were; pressure 0.4 bar, temperature 20°C, design lifetime 20 years. It was assumed that the composite repair would withstand the applied loads and seal without any allowance for the remaining wall thickness of the tank. The design resulted in a thickness of 5 mm (6 layers) of Futurewrap Glass/LT composite repair with an axial length of 260 mm. The repairs on the tank main body were applied as patches.

The installation steps are shown in the photographs. The repair was applied off ropes as the pipework is elevated. The surface preparation was to ST3. Full QA/QC measurements were made to demonstrate that the Futurewrap repairs were applied in accordance with ISO 24817.

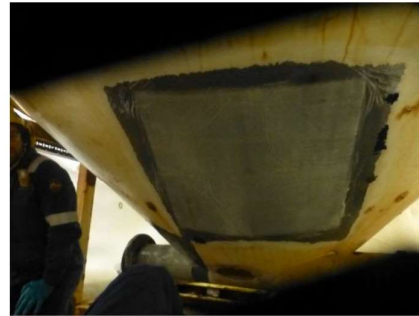
Completed repair – Patch 1

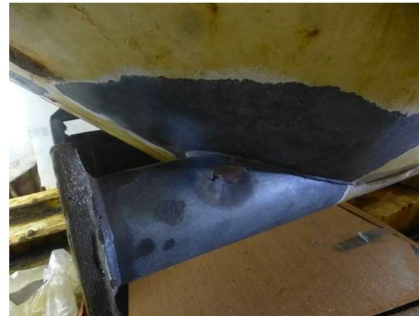
Initial status of tank pipework

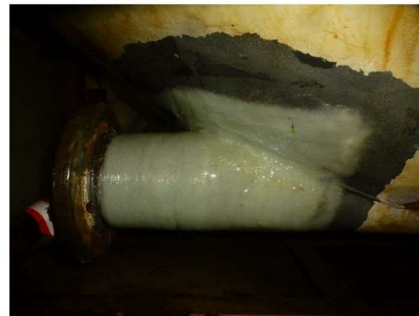
Completed repair – tank pipework

A drilling mud was repaired using Futurewrap Glass/LT composite repairs. The repairs were completed within 3 days reinstating the integrity of the tank.

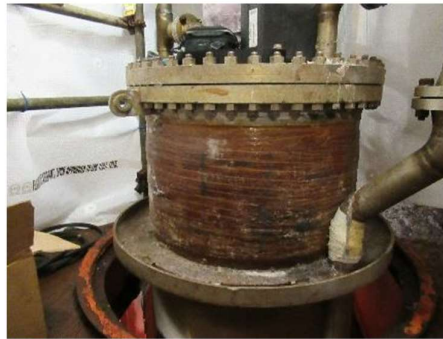
A 32 inch line off a glycol still column was suffering from external corrosion. A previous composite repair had been applied and reached the end of its design life. It was proposed to use a Futurewrap composite repair over the existing repair to reinstate the integrity of the pipework.

Initial condition of pipework

The design of the Futurewrap repair was according to ISO 24817. The design approach was for pipework strengthening and leak sealing (at edges of the composite repair). The design parameters were; internal pressure 3.5 bar, temperature 230°C, design lifetime 15 years, slot through wall defect length of 25 mm. The repair design resulted in a thickness of 5 mm (4 layers) of Futurewrap Carbon/HT composite repair with an axial length of 460 mm.

The installation steps are shown in the photographs. The pipework was depressurised. The surface preparation was to ST2. Heat blankets were used to post cure the repair. Full QA/QC measurements were made to demonstrate that the Futurewrap repair was applied in accordance with ISO 24817.

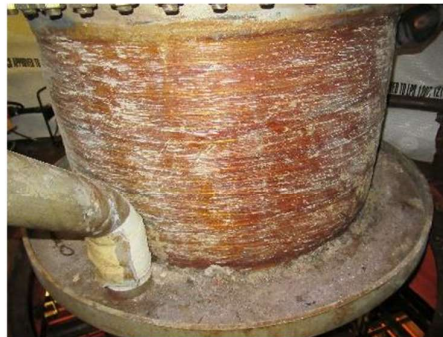
After surface preparation

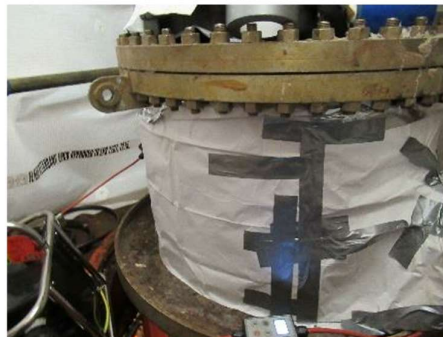
During repair application

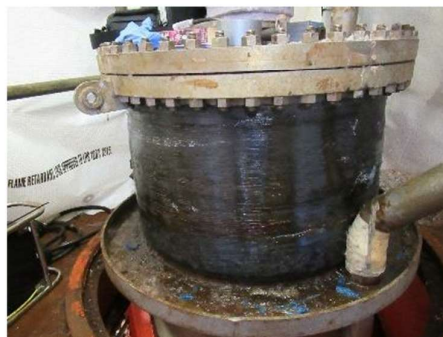
Completed repair

A 32 inch line with an out of date composite repair was repaired using Futurewrap Carbon/HT composite repair. The repair was completed within 6 days allowing the pipework to be re-pressurised returning the pipework to its original integrity.

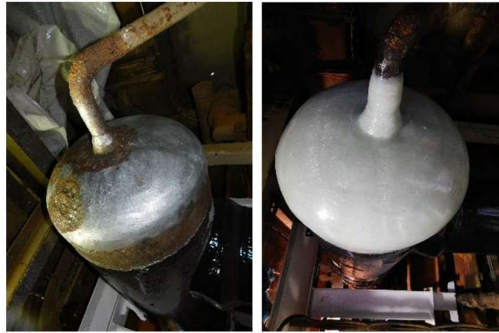
A 24 inch drilling mud line was suffering from external corrosion. It was proposed to use Futurewrap composite repairs over 4 defects to reinstate the integrity of the pipework.

Repair 1 - Initial condition, final repair

The design of the Futurewrap repair was according to ISO 24817. The design approach was for pipework strengthening and leak sealing. The design parameters were; internal pressure 9.2 bar, temperature 50°C, design lifetime 10 years, slot through wall defect length of 50 mm. The repair design resulted in a thickness ranging from 6 to 12 mm (6 to 14 layers) of Futurewrap Glass/LT composite repair with an axial lengths from 650 to 900 mm.

The installation steps are shown in the photographs. The pipework was depressurised. The surface preparation was to ST3. Full QA/QC measurements were made to demonstrate that the Futurewrap repair was applied in accordance with ISO 24817.

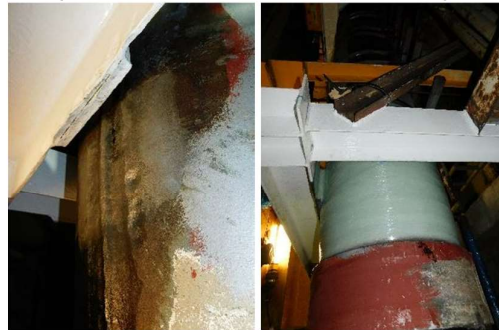
Repair 2 - Initial condition, final repair

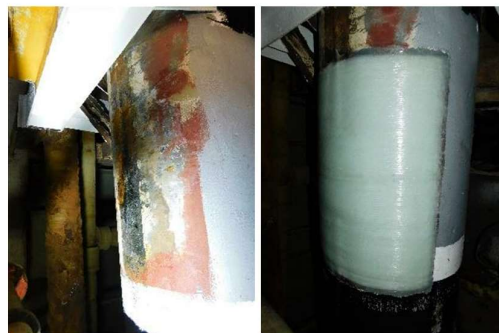
Repair 3 - Initial condition, final repair

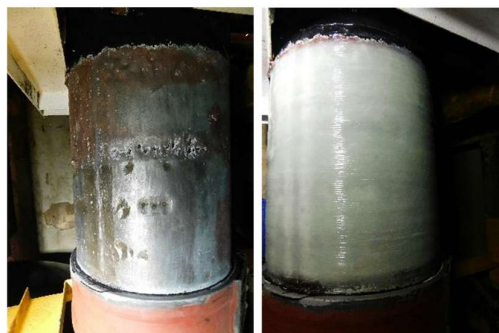
Repair 4 - Initial condition, final repair

A 24 inch drilling mud line was repaired using Futurewrap Glass/LT composite repair. The repairs were completed within 8 days allowing the pipework to be re-pressurised returning the pipework to its original integrity.

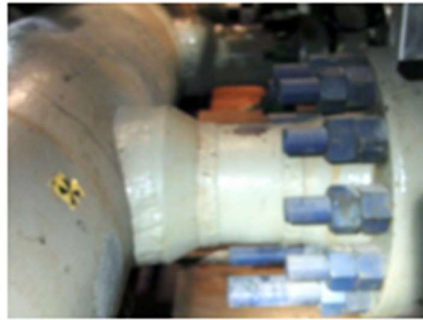
A 20 inch tee with a hydrocarbon export pipework was suffering from internal corrosion. Further internal corrosion was expected to occur and therefore a composite repair solution was sought. To reinstate the integrity of this section of pipework it was proposed to use a Futurewrap Carbon/HT composite repair.

Original status of pipework

The design of the Futurewrap Carbon/HT repair was to strengthen the pipework assuming the internal corrosion rate was 2 mm/year. The design parameters were; pressure 100 bar, temperature 200°C, design lifetime 2 years. It was assumed that the remaining wall thickness at the end of design life was 10 mm. The repair design resulted in a thickness of 18.9 mm (16 layers) of Futurewrap Carbon/HT composite repair with an axial length of 1190 mm.

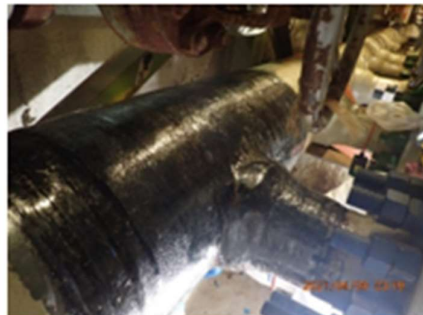
During repair application

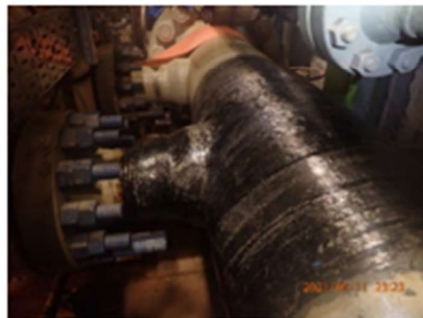
Completed repair

A 20 inch tee section of export pipework system suffering internal corrosion was repaired using Futurewrap Carbon/HT composite repair. The repair was completed within 7 days reinstating the integrity of the pipework.

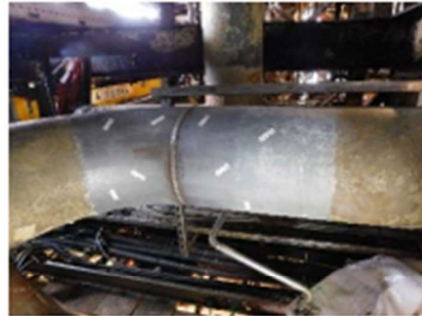
Initial condition of pipework

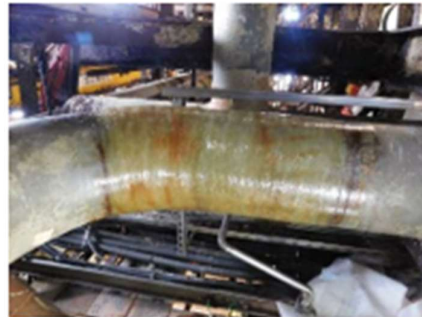
Completed repair

A 16 inch crude oil separator line suffering internal corrosion was repaired using a Futurewrap Glass/HT composite repair. The repair was completed within 3 days allowing the pipework to be re-pressurised with the pipework returned to its original integrity.

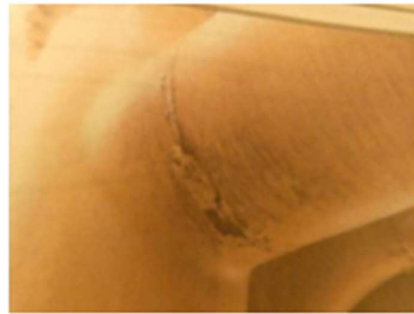
Initial condition of pipework

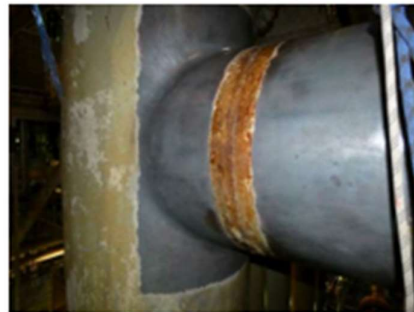
After surface preparation

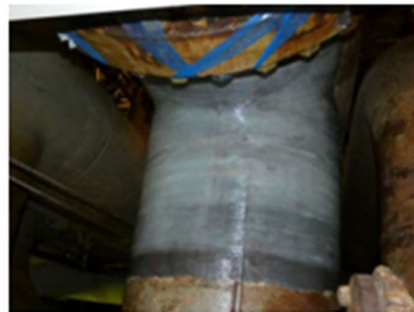
During repair application

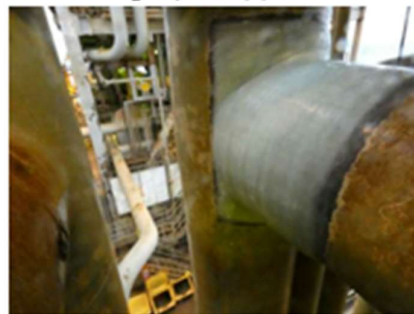
Completed repair

A 30 inch cooling water tee/header suffering severe external corrosion was repaired using Futurewrap Glass/LT composite repair. The repair was completed within 11 days allowing the pipework to be re-pressurised returning the pipework to its original integrity.

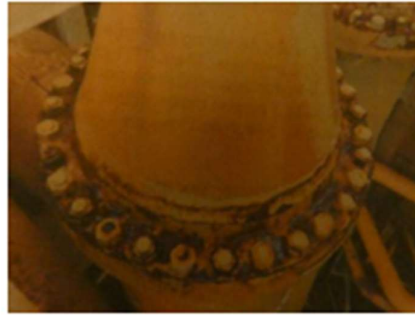
Initial condition of pipework

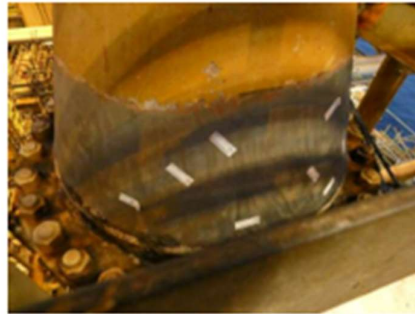
After surface preparation

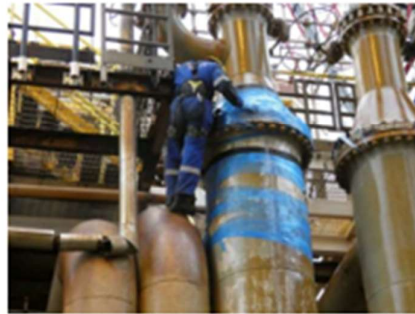
During repair application

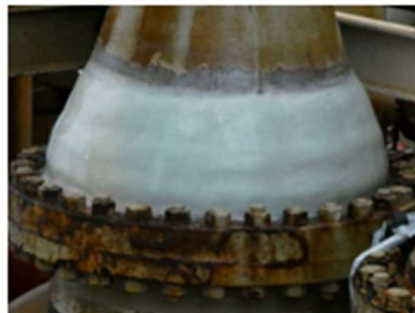
Completed repair

A 36 inch cooling water reducer suffering severe external corrosion was repaired using Futurewrap Glass/LT composite repair. The repair was completed within 11 days allowing the pipework to be re-pressurised returning the pipework to its original integrity.

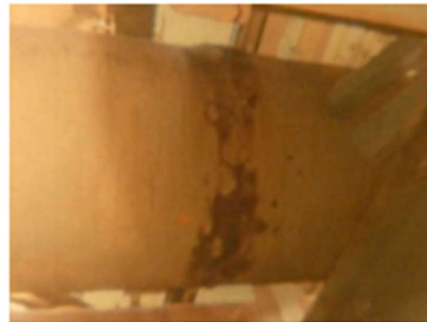
Initial condition of pipework

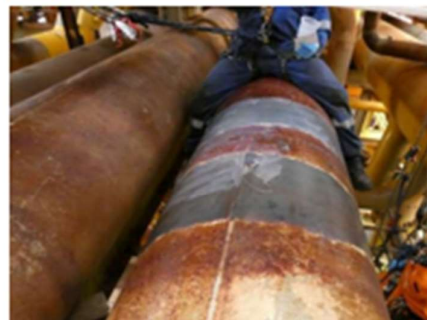
After surface preparation

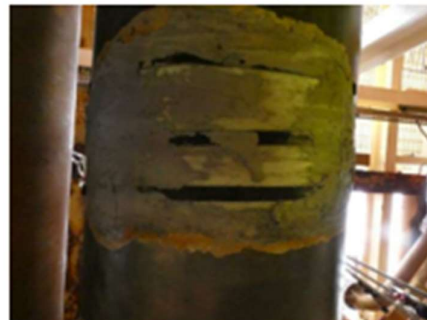
During repair application

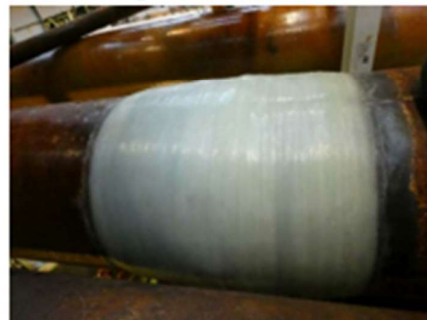
Completed repair

A 30 inch cooling water tee/header suffering severe external corrosion was repaired using Futurewrap Glass/LT composite repair. The repair was completed within 11 days allowing the pipework to be re-pressurised returning the pipework to its original integrity.

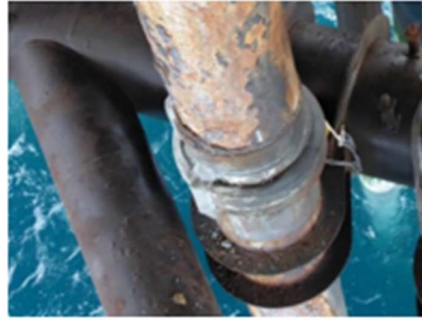
Initial condition of pipework

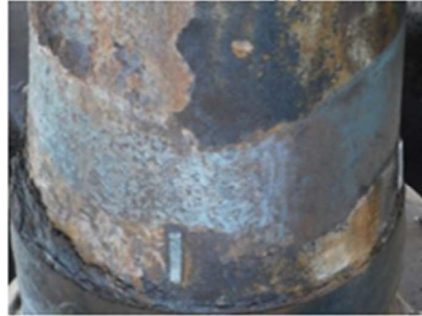
After surface preparation

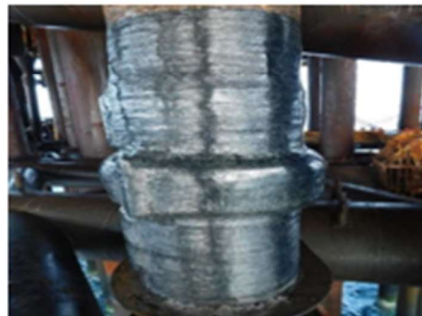
Final cured repair

A 36 inch section of produced water caisson was repaired using Futurewrap Carbon/Aquasplash composite repair. The repair was completed within 14 days allowing the pipework to be re-pressurised and returning it to its original integrity.

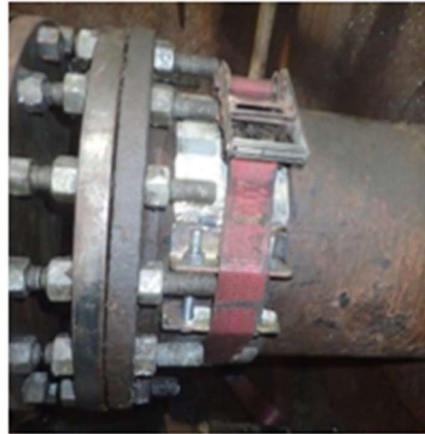
Initial condition of pipework with sealing clamp

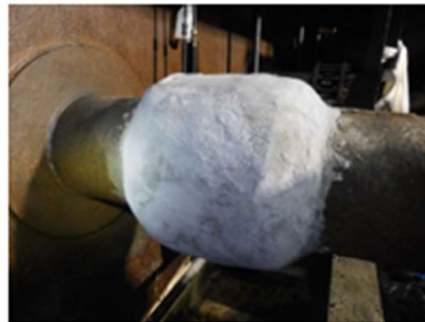
After profiling

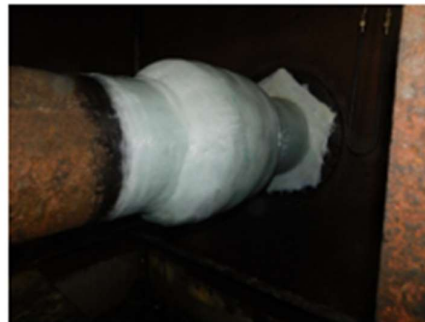
Final cured repair

A 14 cargo line suffering internal corrosion at a weld neck flange was repaired using a Futurewrap Glass/LT composite repair. The repair was completed within 5 days allowing the pipework to be returned to its original integrity.

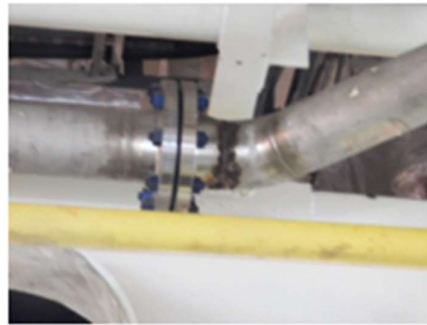
Initial condition of pipework

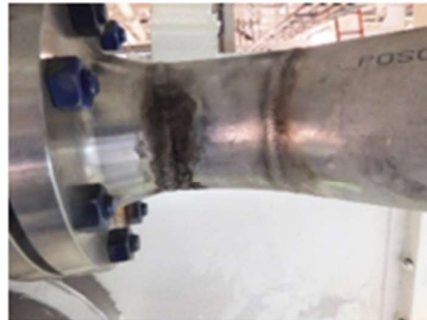
After surface preparation

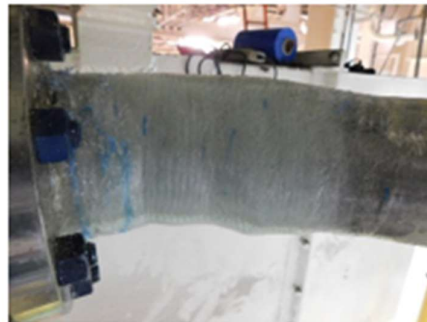
Completed Glass/LT repair

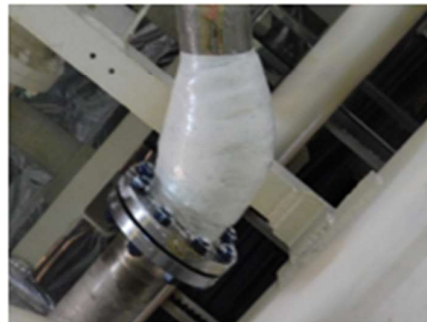
Completed repair with Fire repair

A 4 inch Hi Ex foam line suffering internal corrosion was repaired using a Futurewrap Glass/LT composite repair and fire protected with a Futurewrap Fire repair. The repair was completed within 5 days allowing the pipework to be returned to its original integrity.

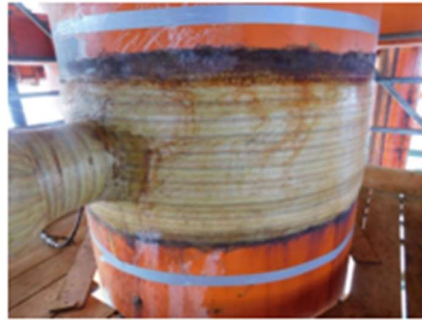
Initial condition of pipework and repair

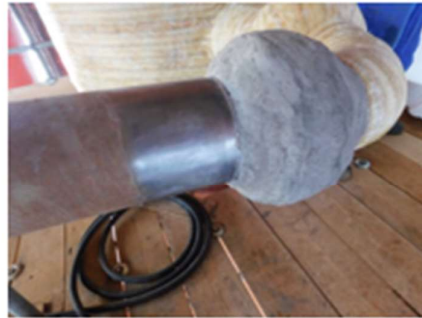
After surface preparation and profiling

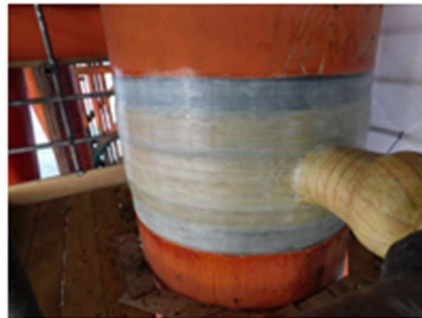
During repair installation

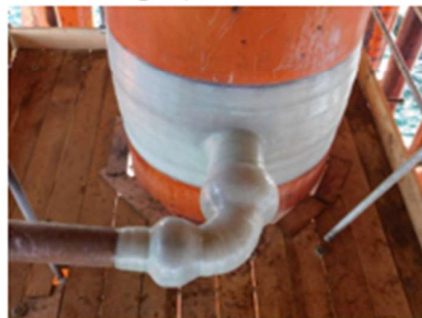
Final cured repair

A 6 inch drains caisson nozzle had an expired composite repair applied. The integrity of the drain line was restored using a Futurewrap Glass/LT composite repair. The repair was completed within 5 days.
