# ENGINEERED COMPOSITE SOLUTION

**FUTUREWRAP**

## **ASSURED INTEGRITY GROUP INCORPORATED**

### Case study – 4 inch seawater injection flowline suffering internal corrosion

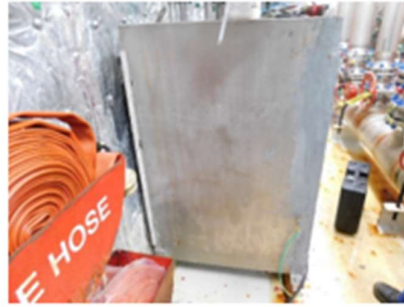
A foam mud tank was repaired using a Futurewrap Carbon/LT composite repair. The repairs were completed within 3 days reinstating the integrity of the tank.

Initial status of tank

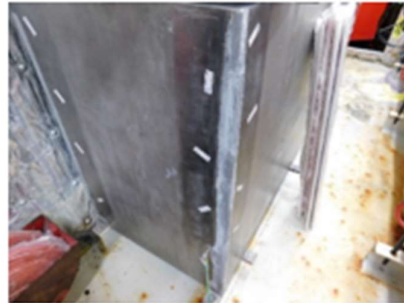
After surface preparation

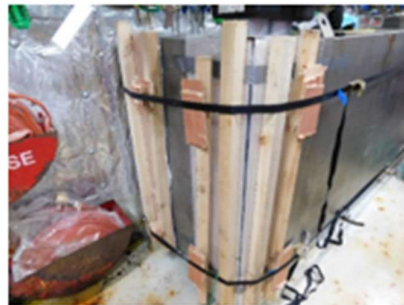
During repair application

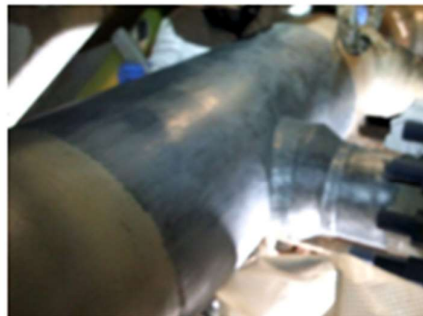
After surface preparation

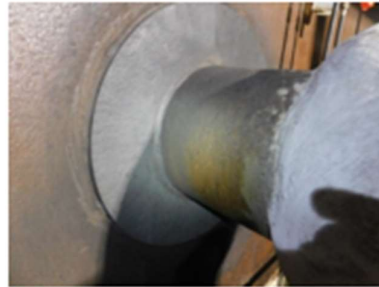
After surface preparation and profiling

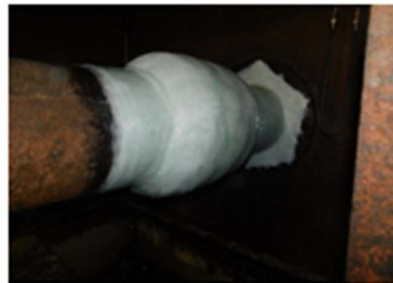
During repair application

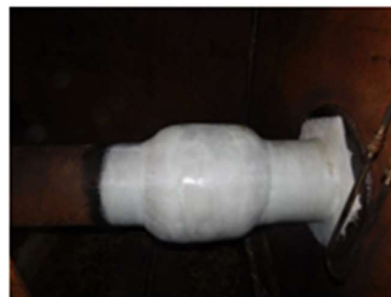
Final cured repair
