# ENGINEERED COMPOSITE SOLUTION

**FUTUREWRAP**

## **ASSURED INTEGRITY GROUP INCORPORATED**

### Case study – 4 inch seawater injection flowline suffering internal corrosion

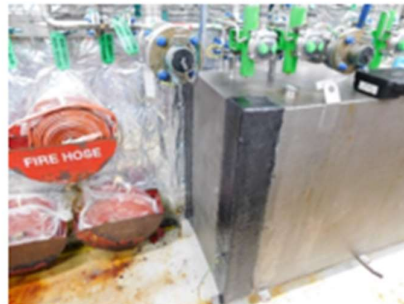
Completed repair

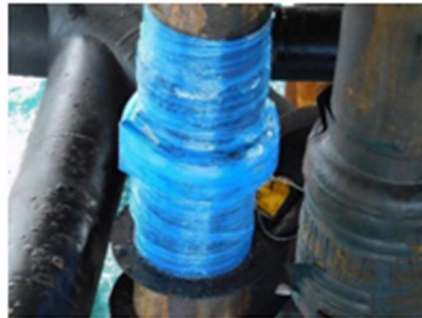
During installation
